MDOT RC-1514

# **Combining Link Slab, Deck Sliding over Backwall, and Revising Bearings**

**FINAL REPORT – AUGUST 2008  
(APPENDICES)**

# **COMBINING LINK SLAB, DECK SLIDING OVER BACKWALL, AND REVISING BEARINGS (Appendices)**

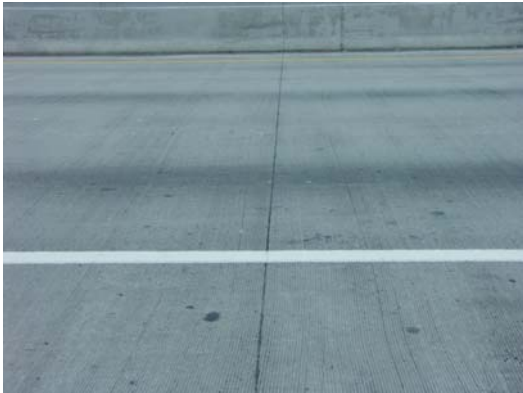
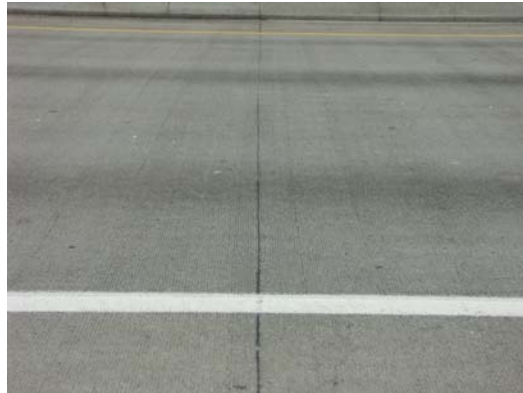
(a) Saw cut on the link slab above the pier centerline

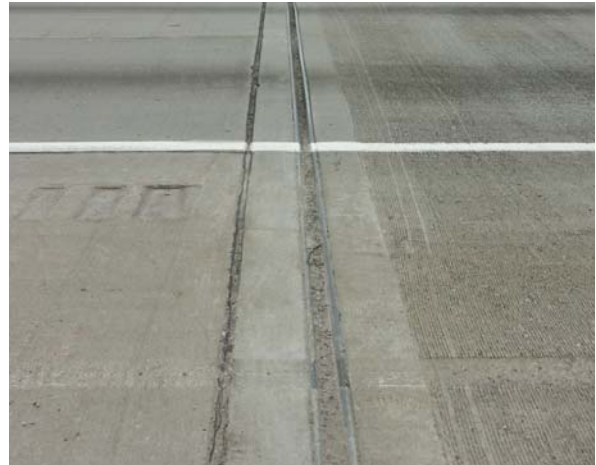
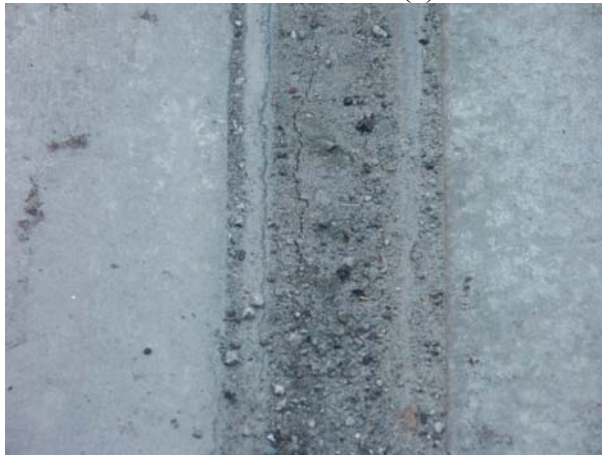
(a) Debris filled expansion joint

(b) Cracks on debris filled expansion joint

**Photo C - 3. Expansion joint condition**

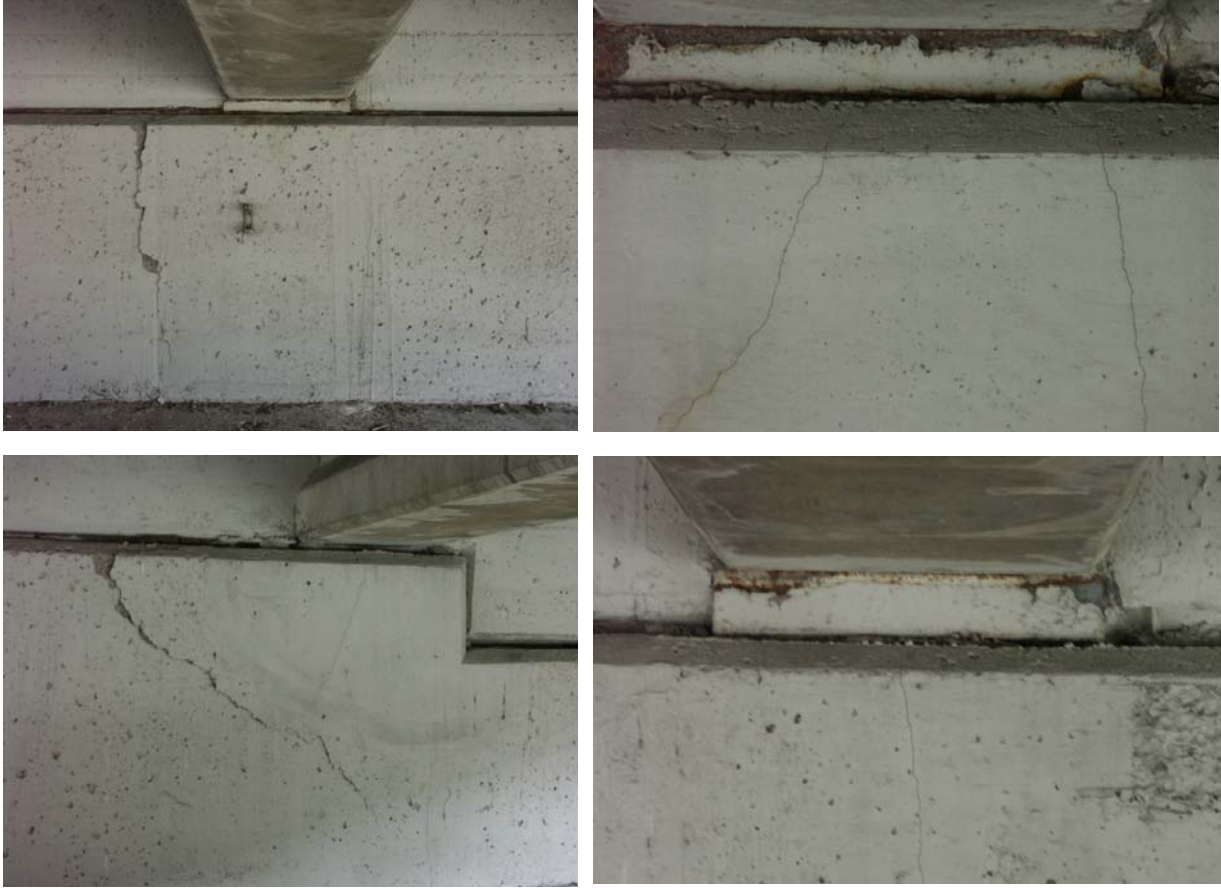
**Photo C - 6. Abutment condition of I-75 north bound**

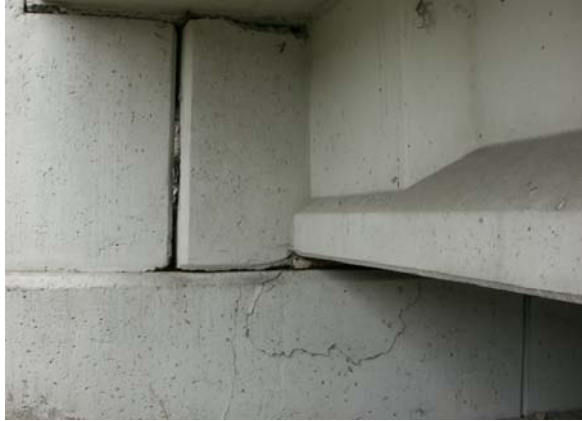
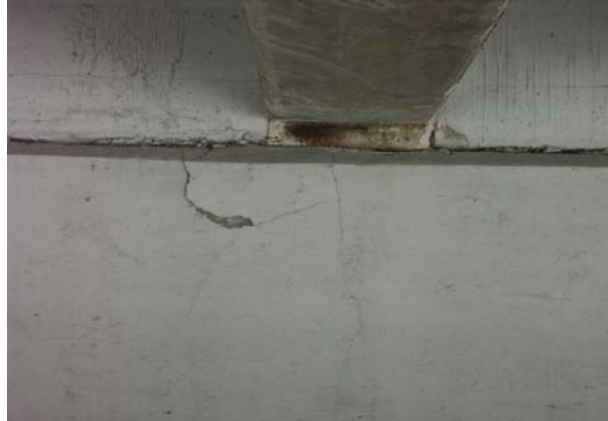
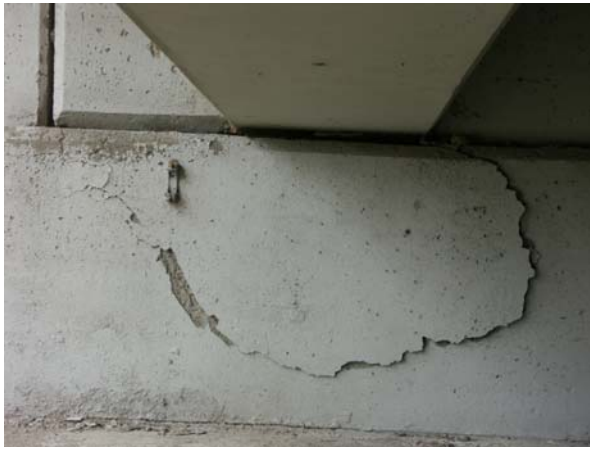
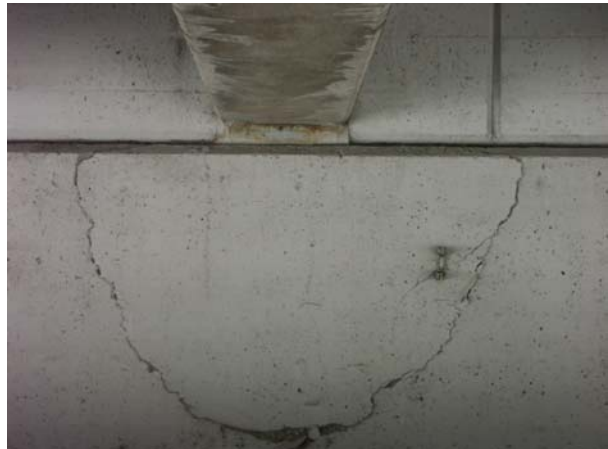
**Photo C - 7. Abutment condition of I-75 south bound**

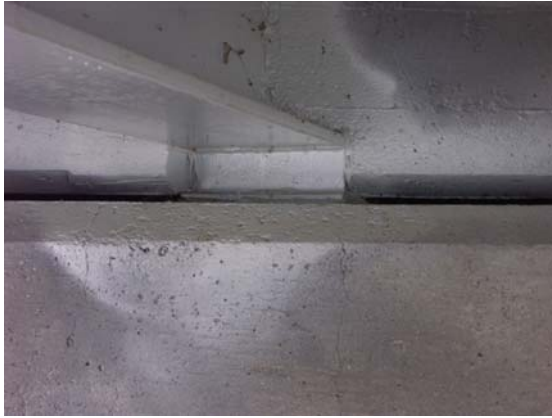
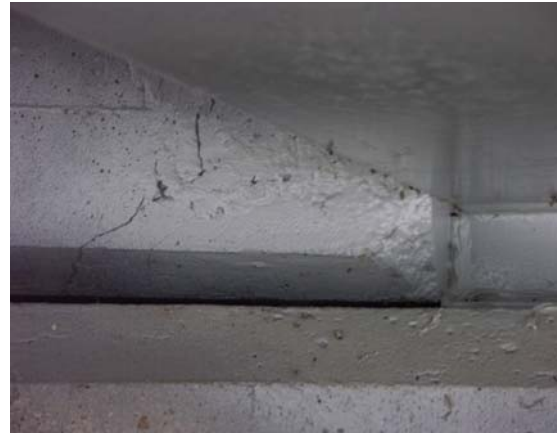
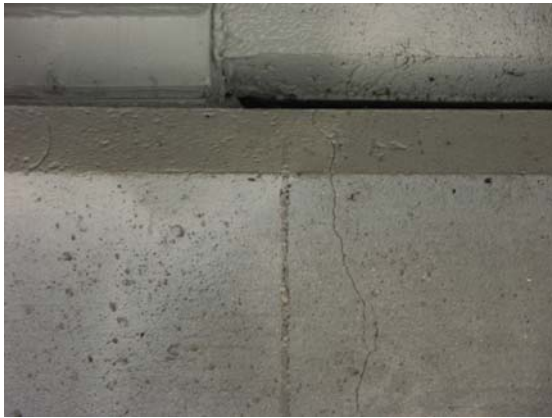
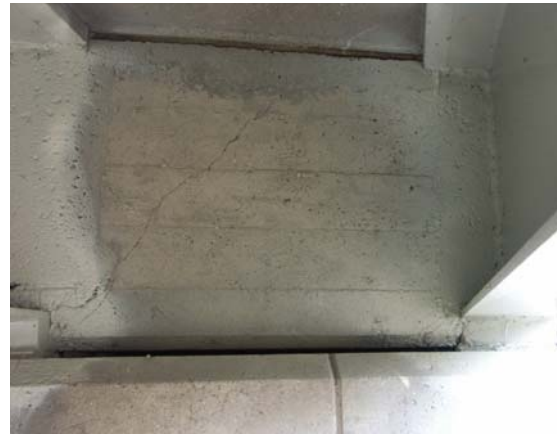
(a) Abutment wall

(b) Backwall

**Photo C - 16. Cracking of (a) abutment wall and (b) backwall**

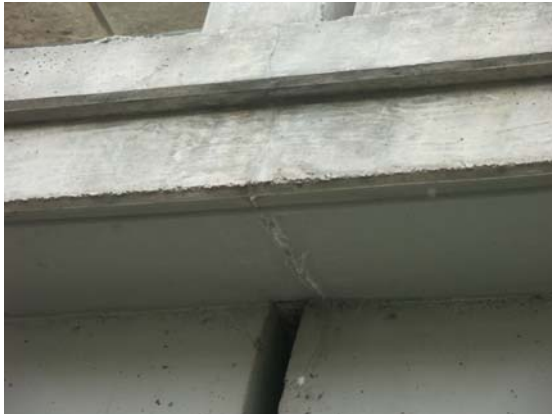
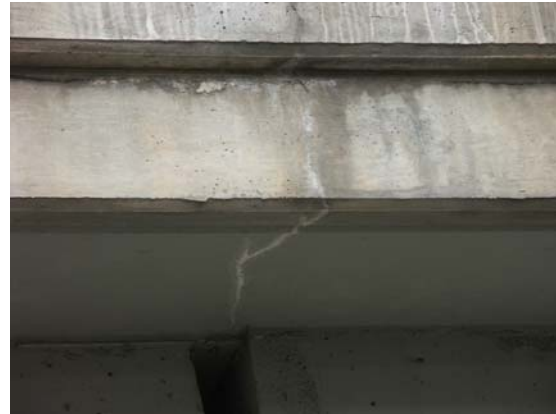
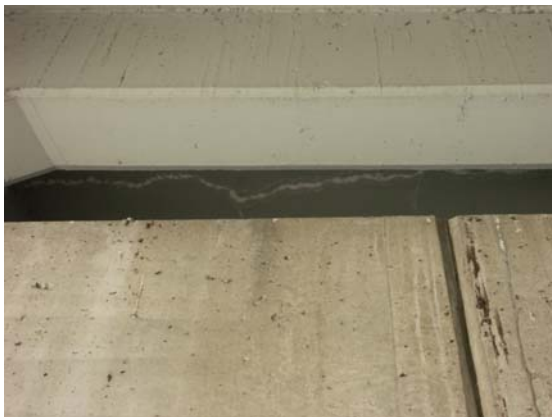
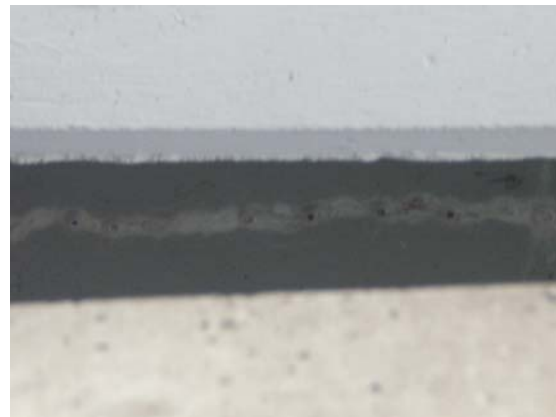
**(a) I - 69 EB**

**(b) I - 69 WB**

**Photo C - 18. Link slab condition of I - 69 (a) EB and (b) WB**

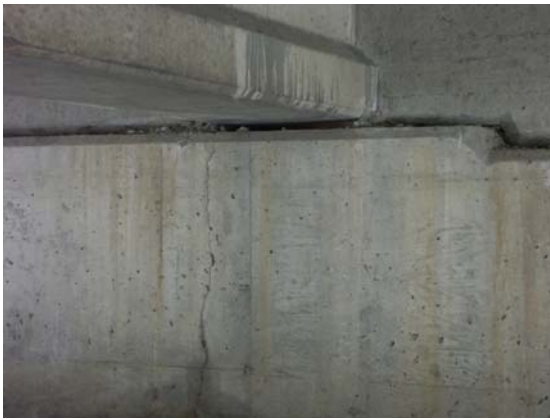
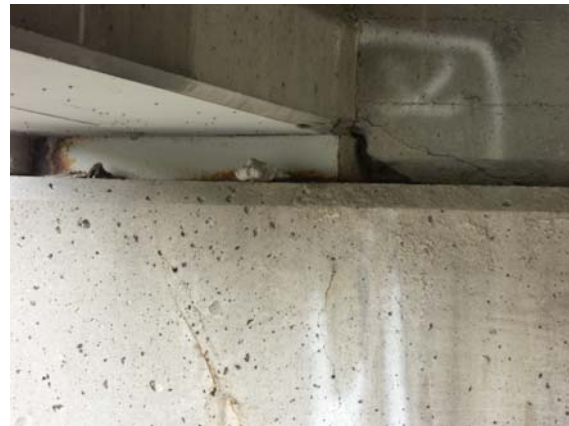
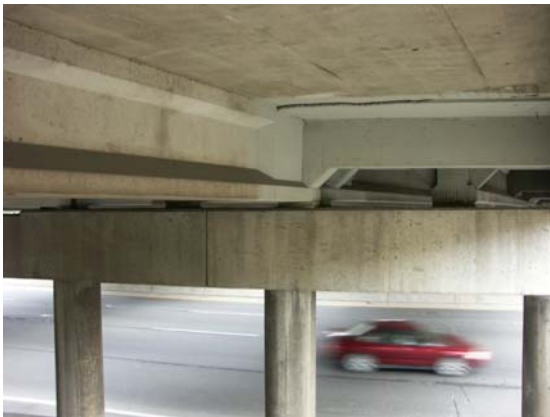
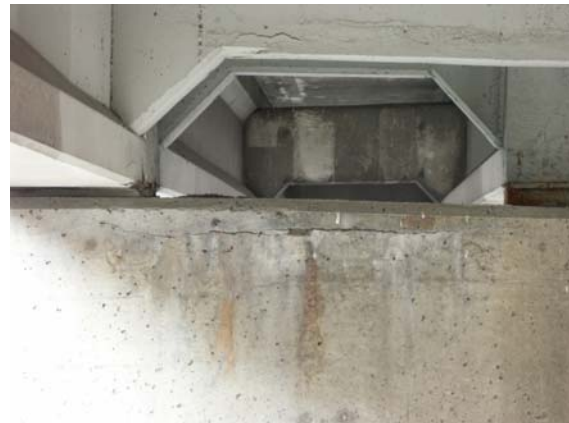
**(a) I-69 EB**

**(b) I-69 WB**

**Photo C - 23. Abutment and pier cap conditions**

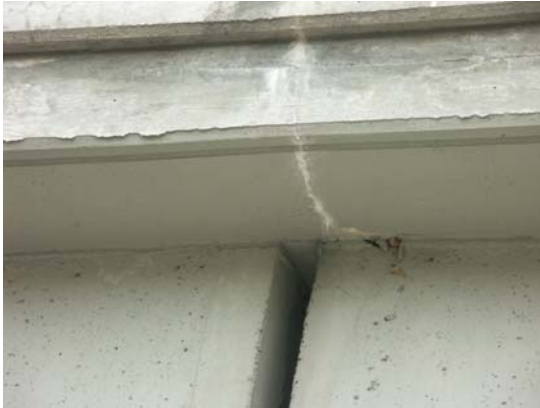
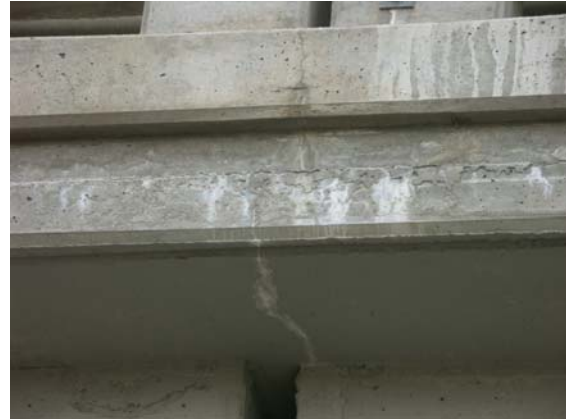
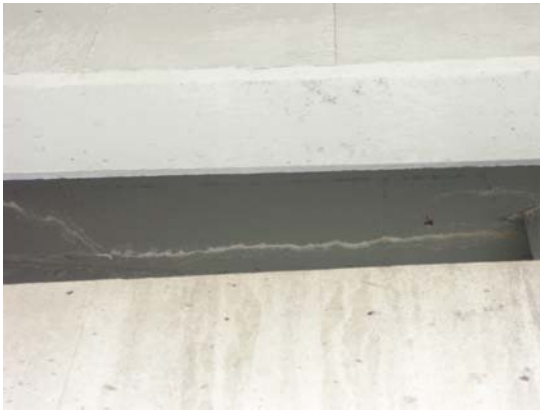
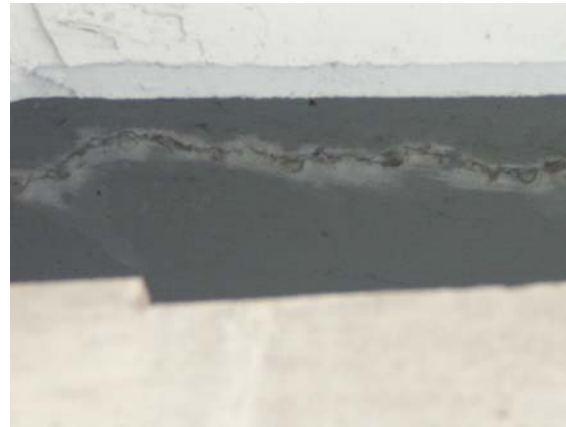
**(a) I – 69 EB Ramp**

**(b) I – 69 WB Ramp**

**Photo C - 24. Link slab condition (a) I-69 EB ramp and (b) I-69 WB ramp**

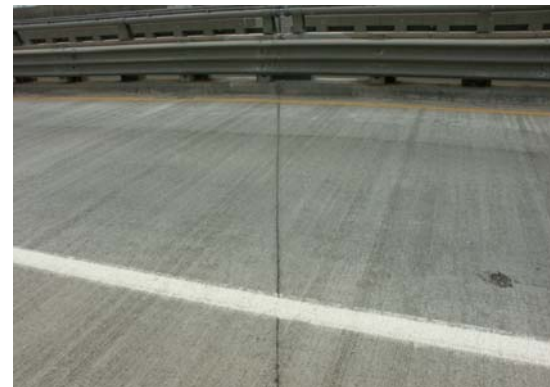
**(a) I – 69 EB Ramp**

**(b) I – 69 WB Ramp**

**Photo C - 25. Saw cut on link slab over the piers**

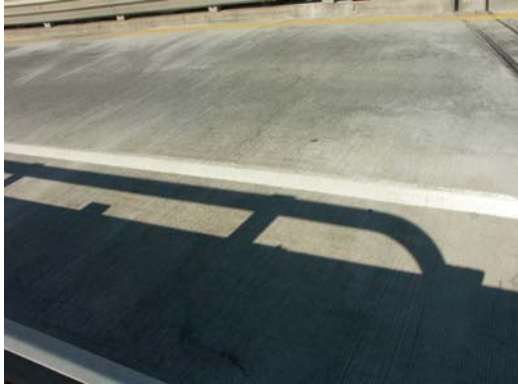
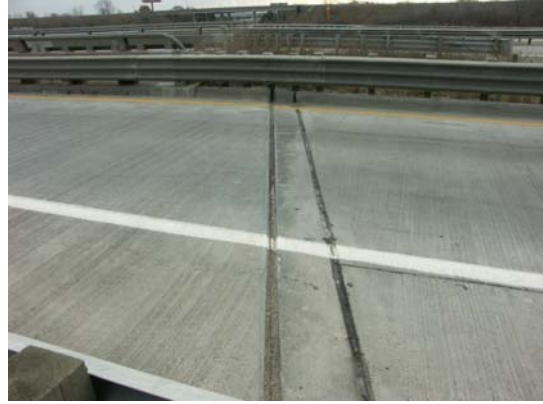
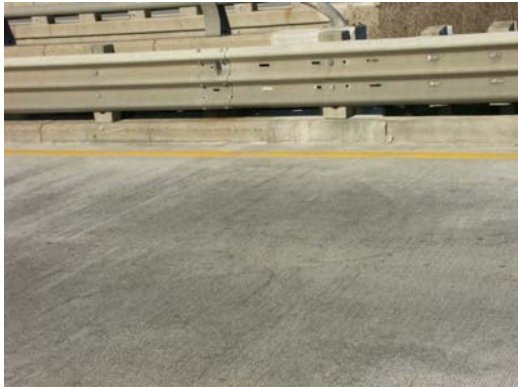
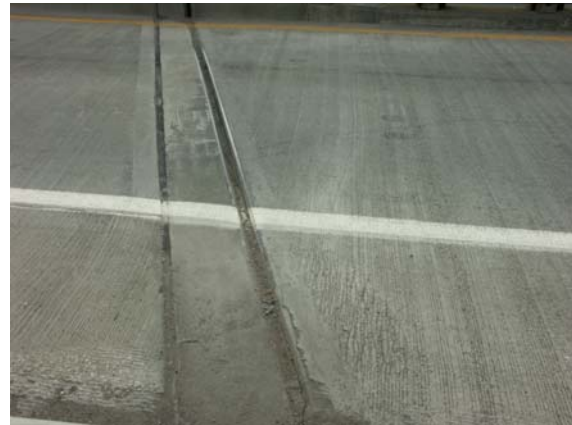
(a) I – 69 EB Ramp

(b) I – 69 WB Ramp

**Photo C - 26. Approach slab condition of I-69 (a) EB ramp and (b) WB ramp**

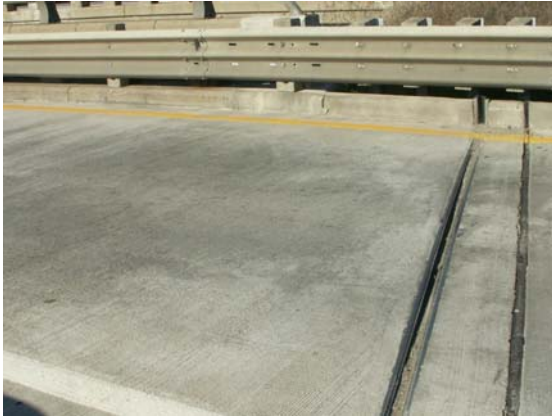
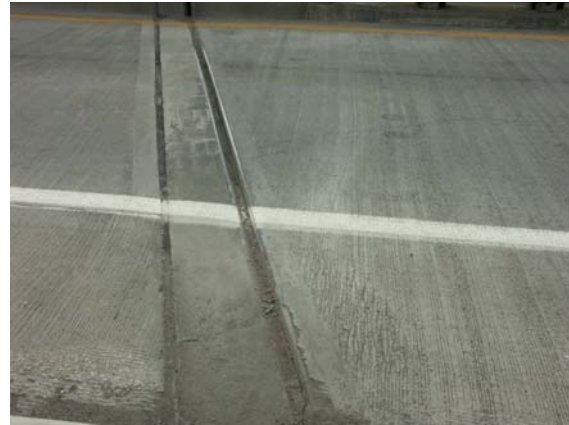
(a) I – 69 EB Ramp

(b) I – 69 WB Ramp

**Photo C - 27. Expansion joint condition of I-69 (a) EB ramp and (b) WB ramp**

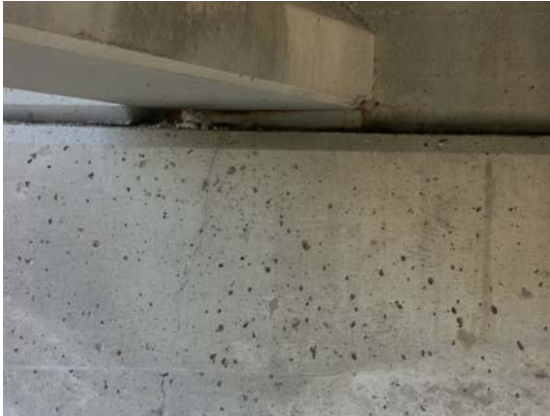
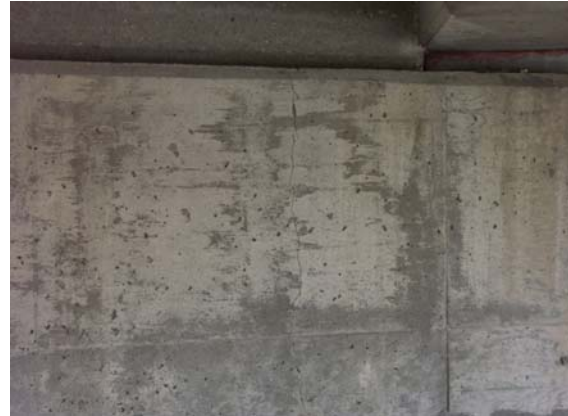
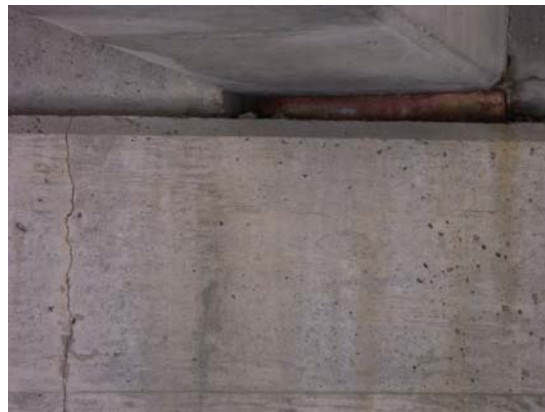
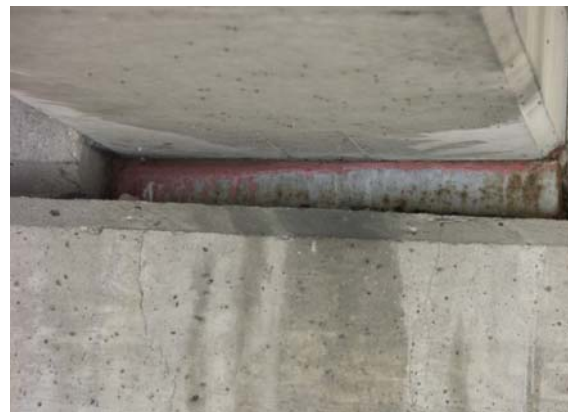
(a) I – 69 EB Ramp

(b) I – 69 WB Ramp

**Photo C - 28. Abutment wall condition of I-69 (a) EB ramp and (b) WB ramp**

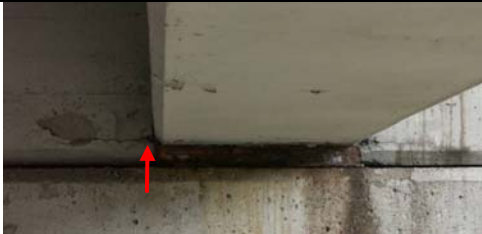
<p data-bbox="894 527 1347 554">Horizontal backwall crack at beam 1W</p>

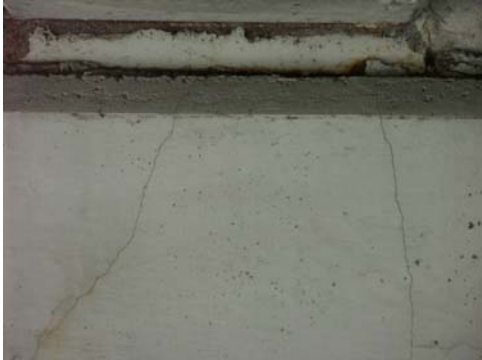
<p data-bbox="943 1417 1299 1444">Vertical crack under beam 7W</p>

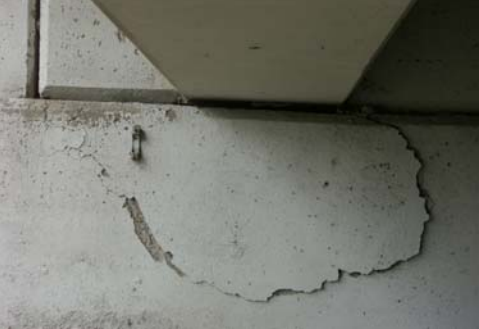
<p data-bbox="215 552 841 583">Abutment wall D-crack and incipient spall - beam 1W</p>

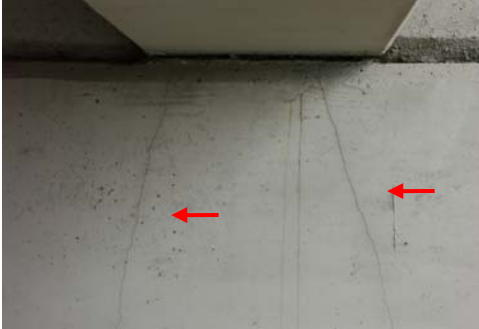
<p data-bbox="963 552 1325 583">Vertical crack under beam 1W</p>

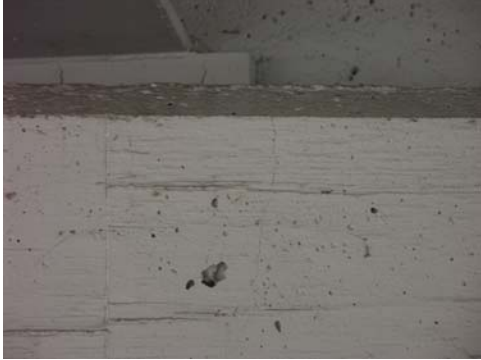
<p>Vertical crack under beam 4W</p>

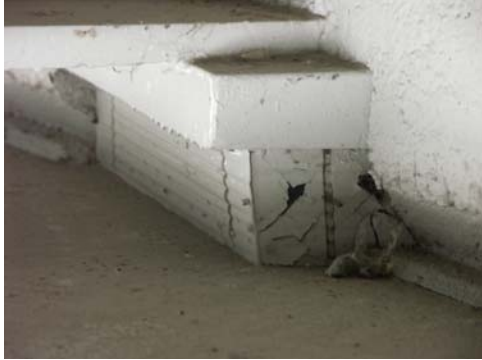
11/4/2006	Abutment wall vertical cracks. Abutment wall vertical cracks under beams 3W and 8W. Deformed bearing under beam 6W.	Abutment wall vertical cracks. Abutment wall cracking on SW face under backwall. Abutment wall vertical cracks under beam 4W.

<p>Deformation of bearing beam 6W</p>

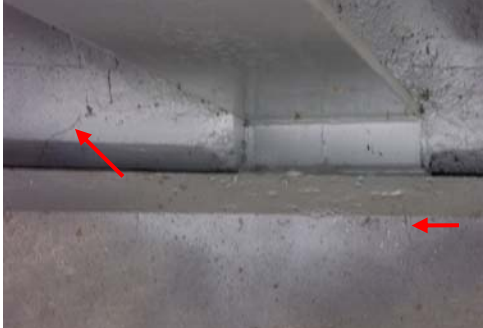
<p data-bbox="224 940 777 1003">Vertical crack under 3W and backwall cracking near beam end</p>

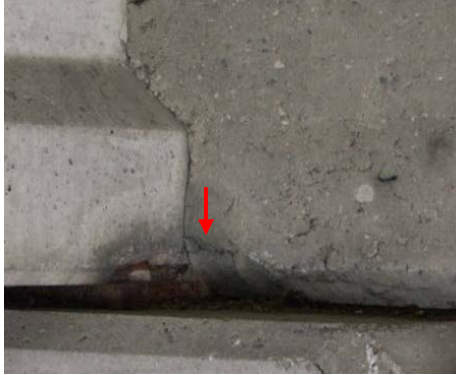
<p data-bbox="943 583 1302 615">Vertical crack under beam 1W</p>

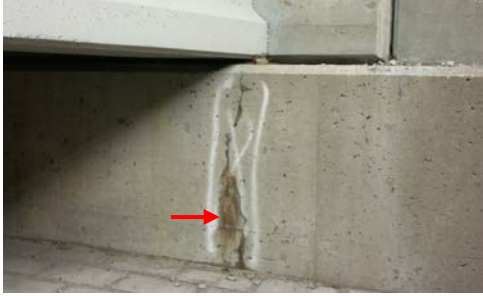
<p data-bbox="951 972 1294 1003">Spalling at beam bearing 1W</p>

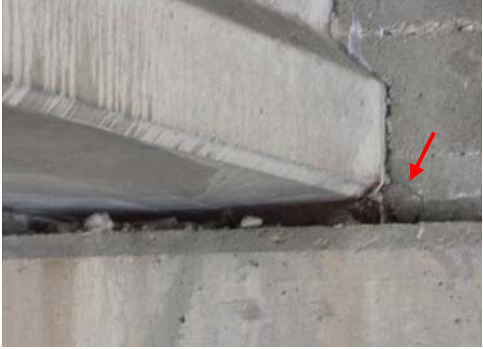
<p data-bbox="321 1339 673 1371">Vertical crack under beam 4W</p>

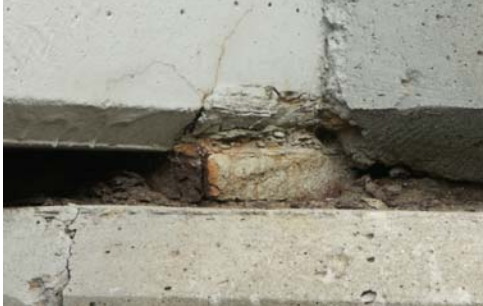
<p data-bbox="849 1350 1396 1381">Horizontal backwall crack at beam bearing 2W</p>

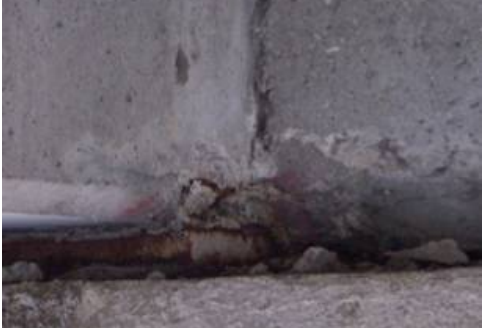
<p data-bbox="212 1675 789 1707">Loss of bearing and backwall cracks at beam 4W</p>

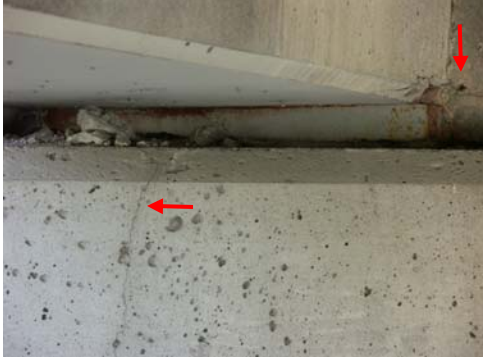
<p>Horizontal backwall and vertical abutment wall cracks at beam 1W</p>

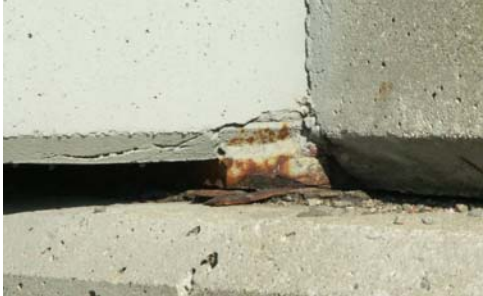
<p>Crack at bearing under beam 3W</p>

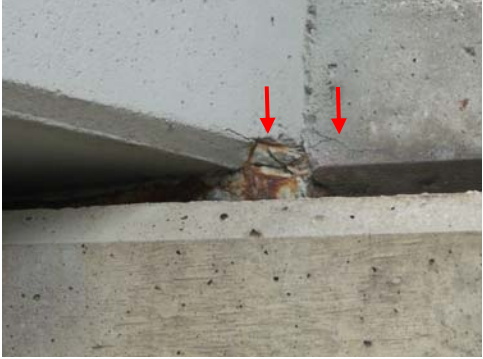
<p>Beam end spall and backwall cracks at bearing of beam 1W</p>

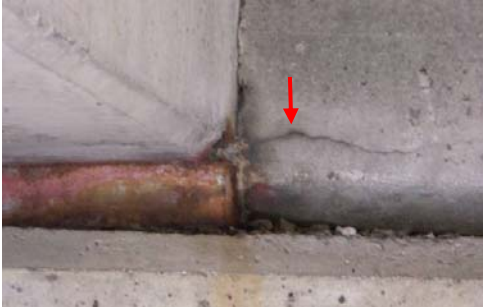
<p>Horizontal backwall crack at beam bearing 2W</p>

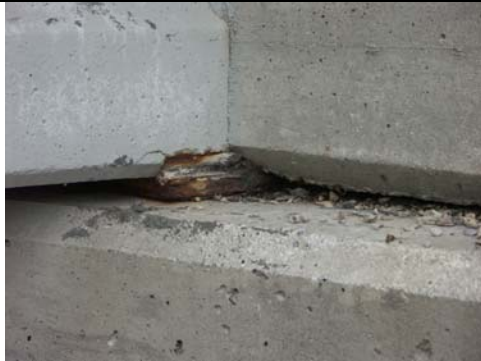
<p>Beam end crack near beam bearing 1W</p>

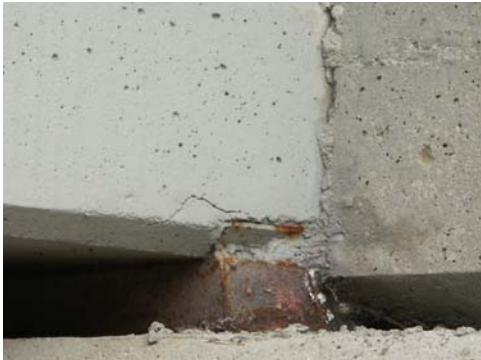
<p>Beam end crack near beam bearing 3W</p>
